HISTORIC  
NEW ENGLAND

PROPERTY CARE WHITE PAPERS • 2026

## Interior Thresholds and Accessibility in Historic Houses

by BEN HAAVIK

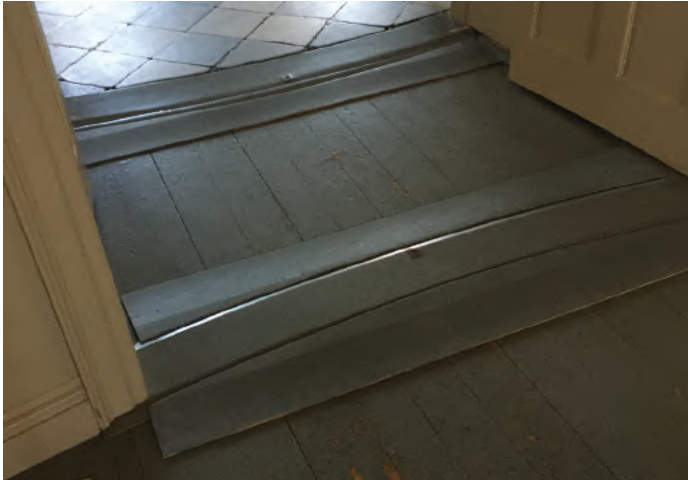
*Thresholds and wooden threshold transitions at the Gore Estate.*

The Gore Estate (owned by the Gore Society) is not a Historic New England property. On a visit to the site, we admired the custom-designed wood transitions that fit perfectly within tight confines and supported smooth access within the space.

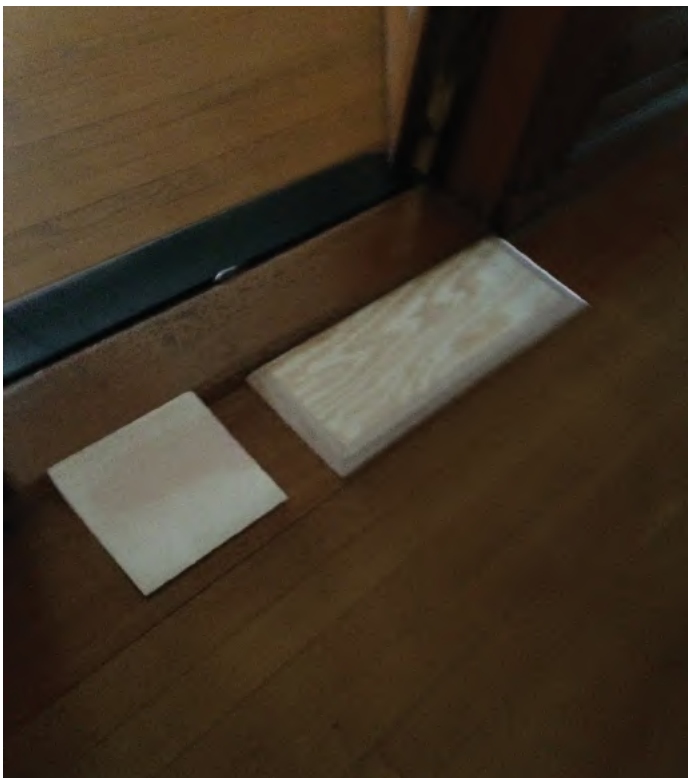
At Historic New England's Eustis Estate in Milton, Massachusetts, we mocked up rubber and wood transition strips for the threshold (see image—rubber oriented to the top of the image, wood to the bottom) so they could be evaluated by staff. The state access board approved the rubber for use, but a technical review with local potential users revealed that the rubber transition selected did not actually enhance accessibility.

We also tested custom wooden transition strips but found that they disrupted the visual flow of the space and impeded access along the hallways, so we pursued alternative methods, ultimately settling on a combination of strategies 2 and 3.

*Mock-ups at the Eustis Estate to review a rubber transition strip, as well as two variants of wood.*

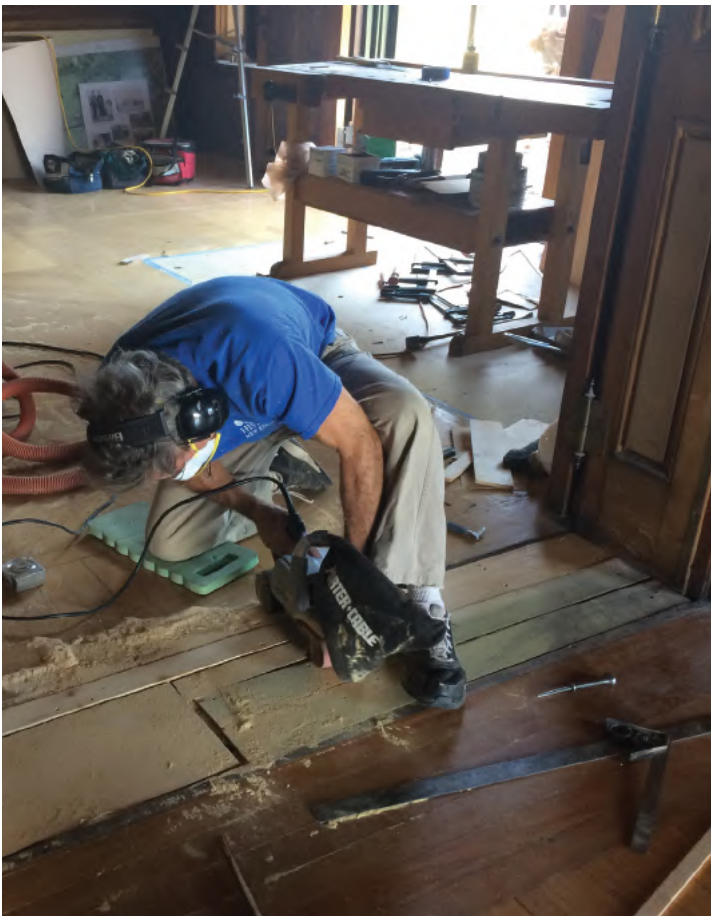
At the Eustis Estate, the original interior thresholds were over 3/4 inch and needed modification. We documented, removed, and archived all thresholds within the circulation path. We then employed two methodologies to address the threshold heights; this example highlights one method, while the other

is featured in Strategy 3. In the main hall of the Eustis mansion, we felt that the thresholds helped define the front hall space and their removal would have negatively impacted the spatial experience. Therefore, we recreated the thresholds at a height that complied with ADA standards.

*Historic New England preservation carpenter sanding the existing filler pieces once the threshold was removed.*

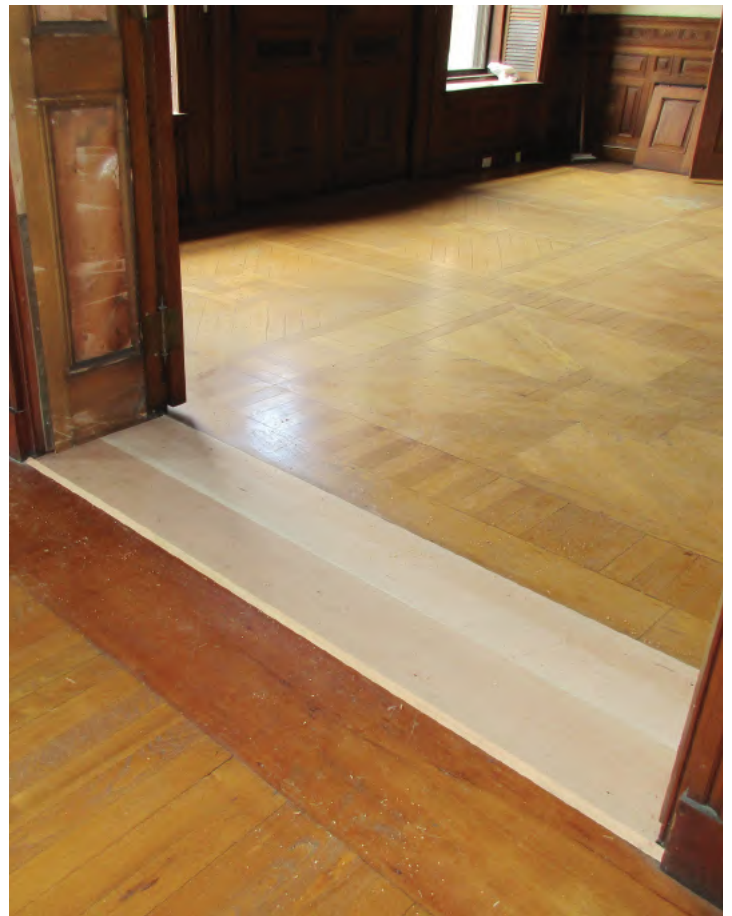
*Replacement threshold installed in the same location at ADA compliant levels, before staining and final treatments.*

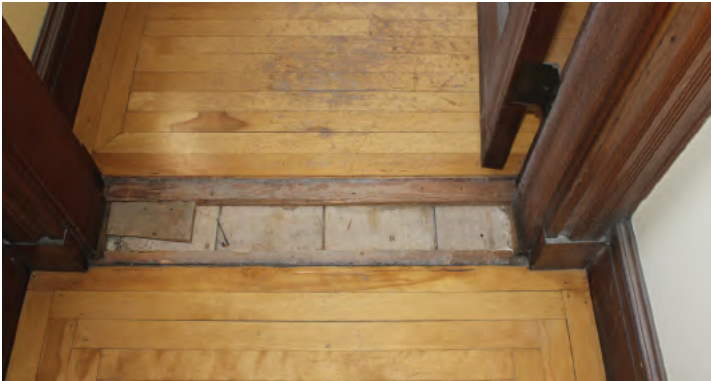
Once we removed the thresholds, we found they were covering spaces with loose wood filler pieces. We documented the loose pieces, removed them from the subfloor, and archived them. We then installed a new solid piece of wood flush with the surrounding floors to emulate a threshold without any changes in elevation.

*Threshold has been removed, showing the filler pieces used at the Eustis Estate.*

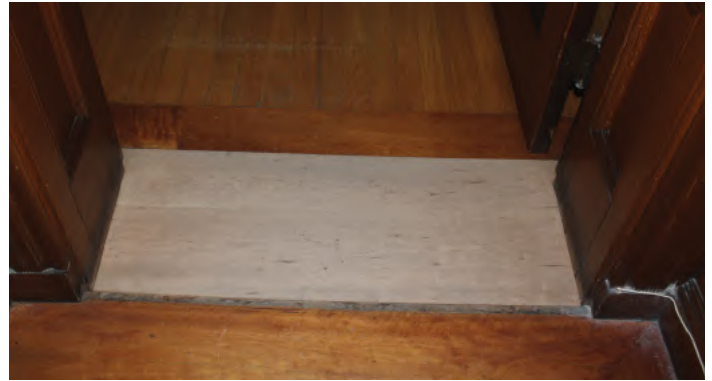
*The filler pieces were removed and a new threshold was inserted into the subfloor and flush with the surrounding floor. This image is before staining and final treatments.*

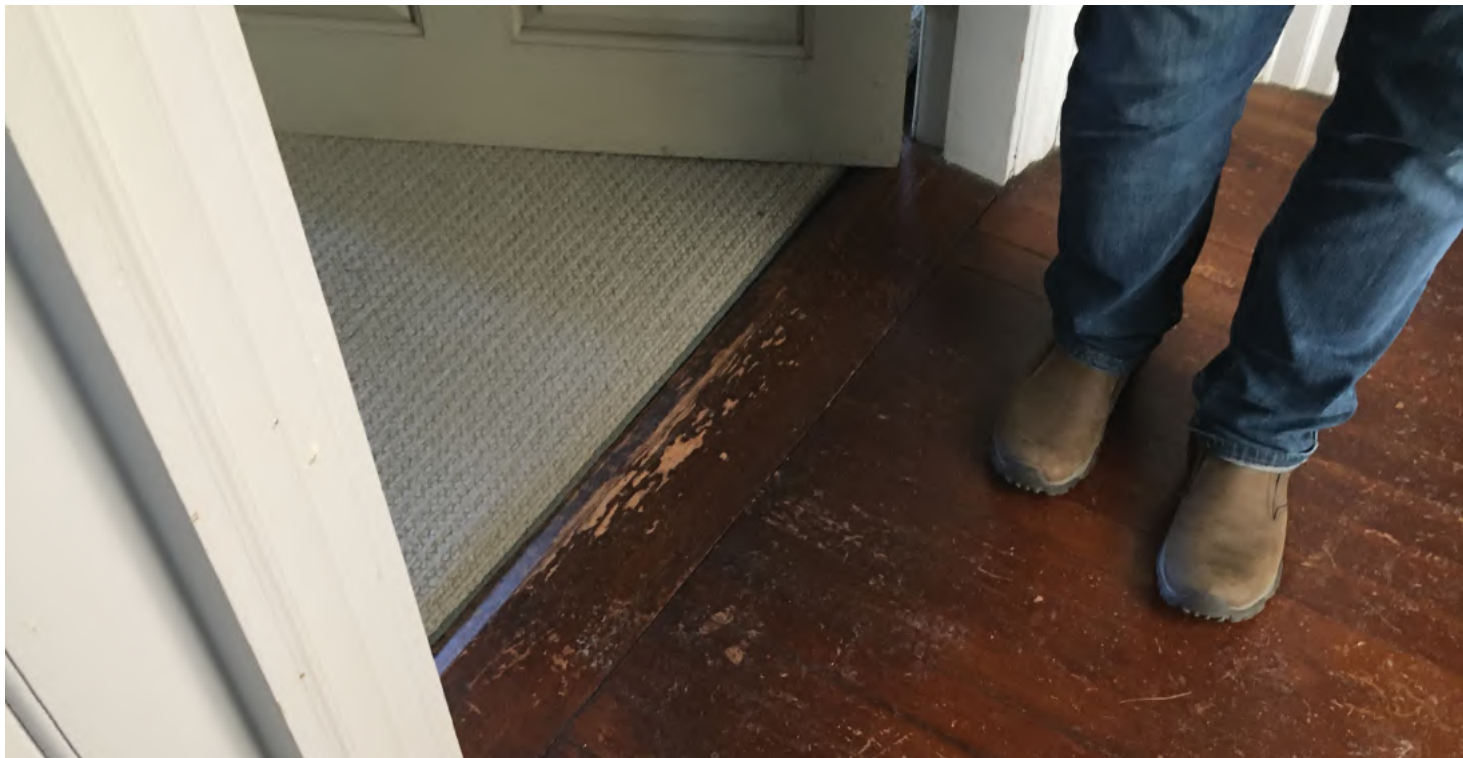
This carpet at Langdon House smooths out the transition between the threshold and the room beyond.

*With feet for scale, this image shows the historic threshold transition between the hall floor and the carpet on the other side. The historic threshold meets ADA requirements.*

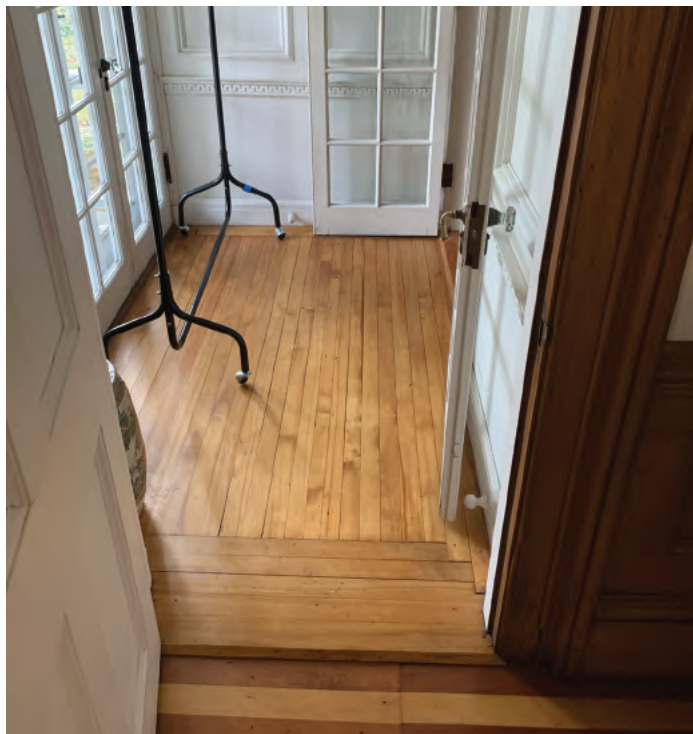
This pass-through space at Phillips House is a candidate for either a carpet or a replica floor to eliminate level changes caused by thresholds at each door. The intervention is suitable because of the small size of the space and the low interpretive importance of the flooring in this area.

*Pass through space at Phillips House that is important to the current tour path but has opportunities for access improvements.*
